## **Bel Pre Recreational Association-FY22-FINAL**

### Level I Full Reserve Study

September 21, 2022

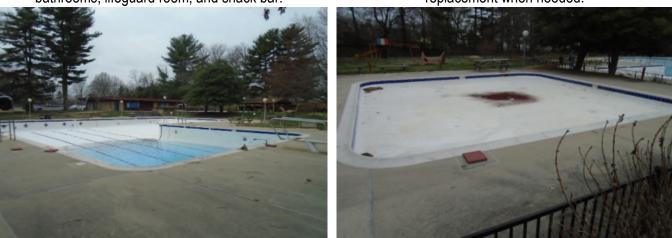
The club has two swimming pools. The wading pool (right photo) is 925 square feet and the main pool (left photo) contains 6930 square feet. The last major pool renovation was in 1996. Both pools were white coated with coping tile repairs in 2019 and are on a 10 year cycle. The condition of the pool piping is unknown. If the piping needs to be replaced, it would require replacement of pool deck.

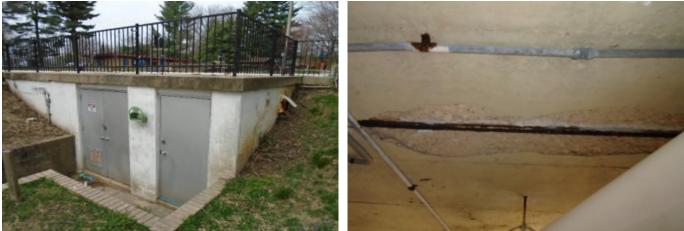
Main pool pump room is located below main pool deck. Roof slab and bearing wall of pump room has possible structural deterioration, and was evaluated by a structural engineer in 2016, who recommended repair of slab and wall damage. Pump room should be repaired or re-evaluated by a structural engineer in the near term. Reserves budget for repairs to be completed in FY23.

MAIN PUMP ROOM CEILING SLAB REPLACEMENT		LS	N/A	2	21,000	,	17,400	,	8,700	0	21,390	0	0	0	0	00,010	0	0	0
COPING/TILES/WALLS & GENERAL REPAIRS		LS	10	8	62,840	,	52,080	,	6,510	0	21,000	0	0	0	0	0	71,590	0	0
DIVING BOARD	1	EA	15	5	9,000	,	7,460	,	1,490	0	0	0	0	9,700	0	0	0	0	0
POOL FURNITURE-ANNUAL ALLOWANCE		LS	1	1	600	,	500		500	600	610	620	630	650	660	670	680	700	710
HOT WATER HEATER	1	ĒĂ	15	9	1,730		1,430		160	0	0	0_0	0	0	0	0	0	2,010	0
ADA LIFT CHAIRS	1	EA	10	5	6,330		5,250		1,050	0	0	0	0	6,820	0	0	0	_,0	0
REPAIR/REPLACE CONCRETE DECK	9.645	SF	50	25	177,470	,	147,090		5,880	0	0	0	0	0	0	0	0	0	0
TENNIS/PICKLEBALL COURT(S)	-,				, -	,	,	,	- ,										
COLOR COAT/NETS	4	EA	5	5	38,800	6,640	32,160	2,090	6,430	0	0	0	0	41,800	0	0	0	0	45,880
MAJOR COURT REPAIRS	4	EA	20	20	70,000		58,020	,	2,900	0	0	0	0	0	0	0	0	0	0
10' CHAIN LINK FENCE	666	LF	30	20	29,300	5,020	24,280	390	1,210	0	0	0	0	0	0	0	0	0	0
TOTAL RECREATION					761,790	130,420	631,370	26,510	81,750

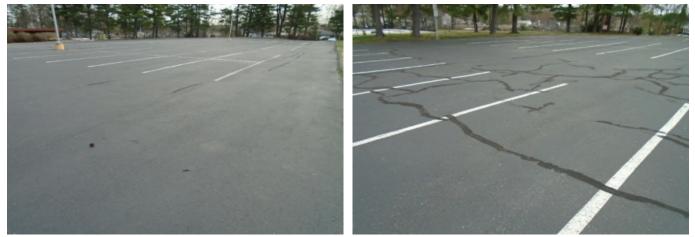
Pavement is holding up well. Parking lot was last milled/overlayed in 2008. Crack filling most recently done in 2020. See our recommendations in the comments section for proper care of asphalt pavements.

PAVEMENTS/CONCRETE	
PAVEMENTS SIDEWALKS/CURBS/GUTTERS OTHER CONCRETE	<ul> <li>The following recommendations should be implemented to extend pavement useful life:</li> <li>1) Have a preventive maintenance program that consist of sealing open cracks (equal to or greater than 1/8"), repair failed surface/base/sub-base areas (distinguished by "alligator" or "chicken wire" cracking), apply a seal coat to the entire surface and repaint traffic markings. An additional benefit of sealcoating and traffic markings is the pavement will look uniform and that enhances property appearance. Although we allow for preventive maintenance to be done every four years, if cracks open or asphalt failures occur sooner they should be repaired as needed as the contingency built into this study should cover the cost.</li> <li>2) Be prepared to mill and overlay around the time period shown in the table. Notes: a) cost of asphalt varies with the price of a barrel of oil, and b) although we allow for 100% of the asphalt to be repaived experience supports a smaller percentage of the base/sub-base will need repairs prior to Repairs as needed to keep components in good repair. Work should be done concurrently with pavement work</li> </ul>

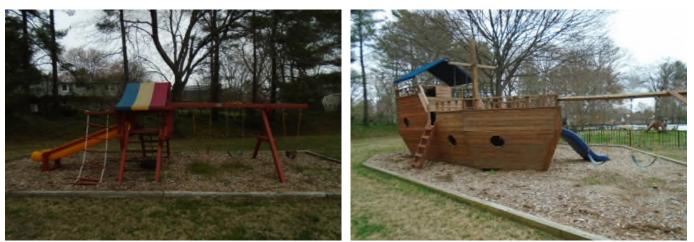
Tot-lots need replacement at end of life and fill replenishment every 2-years-children falling on non-absorbing material causes 70% of tot-lot injuries. Equipment cost will vary with features desired. Funding for mulch replenishment is from the operating account and is not included in the reserves.
